Analysis of End Crack in Boiler Tube

Key words: Boiler tube, end crack, ceramic ferrule, heat flux.

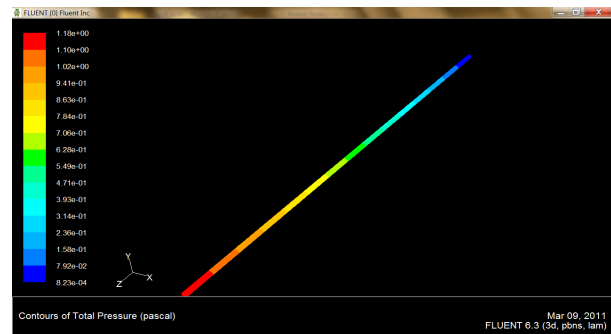
Fig.3: Contour of total pressure in boiler tube

The colour contours, vectors and residual plot were obtained from the FLUENT analysis. In heat transfer analysis it was observed that the pressure ranges from 1.18Pa to 8.23E-4Pa. The highest pressure is at the tube inlet area which is 1.18Pa; while at the outlet pressure is minimal. The pressure distribution is given in Figure 3. The analysis showed that heat flux was constant throughout the tube. There was also no radiation heat transfer. The total heat transfer rate is 1154886.4W across the boiler tube.
