**PLANNING MALAYSIA:**

**VOLUME 21 ISSUE 5 (2023), Page 387 – 401**

## **APPLICATION OF COCONUT COIR MATTING AND VEGETATION FOR RIVERBANK EROSION PROTECTION**

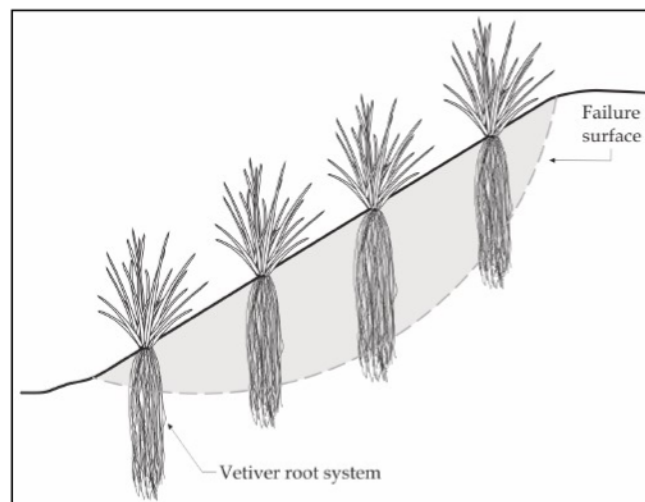
**Figure 1:** Application of vetiver grass as slope protection.  
(Mohd Taib et al., 2020).

A slope profile simulation with and without vetiver grass were done in Malaysia to compare the slope factor of safety concluded that the application of vetiver grass is highly effective in order to provide protection to the slope without considering the its angle as shown in Figure 1 (Mohd Taib et al., 2020). Moreover, vetiver grass is proven to be more affordable and cheaper (Mondal & Patel, 2020). In addition, the authors state that the combination of vetiver grass with other protection measures has the potential to produce long-term riverbank conservation.

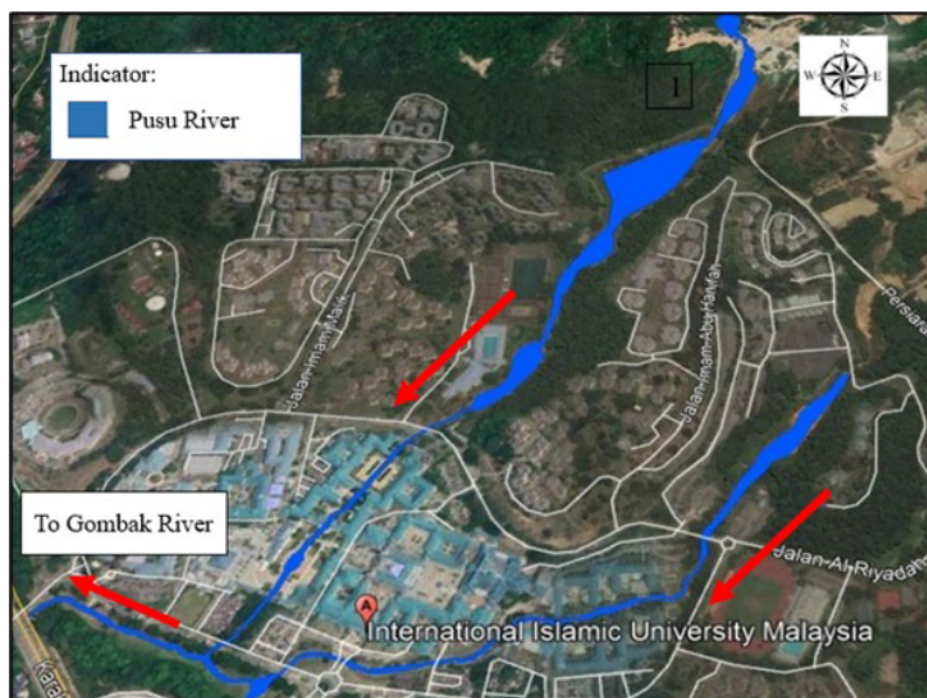
**Figure 2:** The aerial view of Pusu River

One of the earliest stages of this study consists of conducting several site visits to assess the location of the study area and to collect data. The location of the study area is the downstream part of Pusu River as illustrated in Figure 2. Additionally, the Pusu River is one of the tributaries of Gombak River and it is the biggest watercourse in Gombak District. However, upstream of the Pusu River, many activities take place that have a negative impact on the Pusu River ecosystem including illegal construction, illegal logging and illegal farming.

Based on the visual inspection conducted, it can be concluded that Pusu River is facing sedimentation problems and riverbank erosion. The riverbank erosion is majorly due to hydraulic instability as the flow of the river and the volume of water are decreasing gradually due to the high sedimentation concentration in the river.

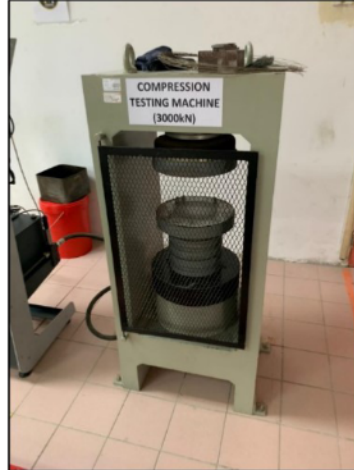
**Figure 3:** Compression Testing Machine

Coconut coir mat can be easily obtained as it is commercially available. In this study, coconut coir mats were fabricated in Kuliyah of Engineering laboratory using Compression Testing Machine, as shown in Figure 3, with reference to ASTM D6525: Standard Test Method for Measuring Nominal Thickness of Rolled Erosion Control Products.

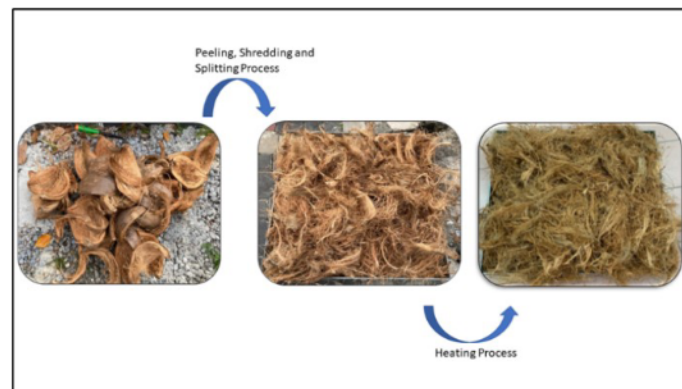
**Figure 4:** Extraction process of coconut coir

The first step of fabrication is to extract the coconut husk to turn it into the coconut coir. This process was done by splitting and peeling the coconut husk from the pith in order to get a fibrous state of coconut coir which is easier to mould and shape. The coconut coir obtained from the previous process is heated in the drying oven at a temperature of 160°C for 5 minutes to complete the process of the extraction as shown in Figure 4.

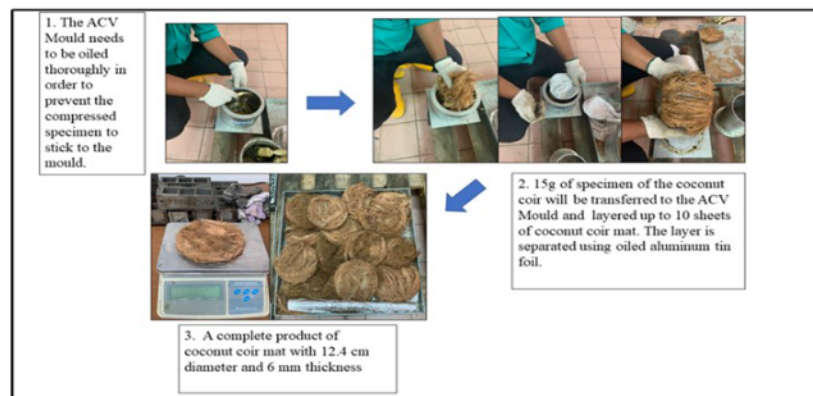
**Figure 5:** Fabrication of coconut coir

The process continues to the fabrication of coconut coir mat by pressing the coconut coir using Compression Testing Machine for 10 minutes with 6 kN pressure in order to fabricate with a thickness of 6 mm as per ASTM D6525: Standard Test Method for Measuring Nominal Thickness of Rolled Erosion Control Products. The coconut coir is fabricated using Aggregates Crushing Value Mould and prepared using a special method in order to produce the coconut mat in the most efficient manner and applicable to the Compression Testing Machine as shown in Figure 5.

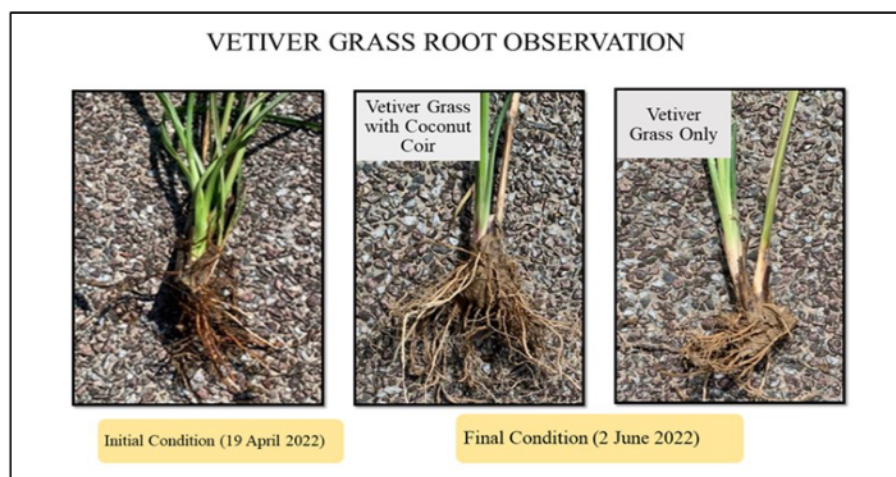
**Figure 6:** Vetiver grass root visual observation

Figure 6 shows the visual comparison of the vetiver grass root observation at initial condition taken on 19 April 2022 and its final condition taken on 2 June 2022. From the observation, it can be seen that vetiver grass roots with coconut coir grew more expansively compared to those without coconut coir. This finding could be attributed to the application of coconut coir seemingly being beneficial to the growth of vetiver grass roots. This is in agreement with Jaafar et al. (2020) where coconut coir matting helps vegetation development and provides extra reinforcement on the soil.

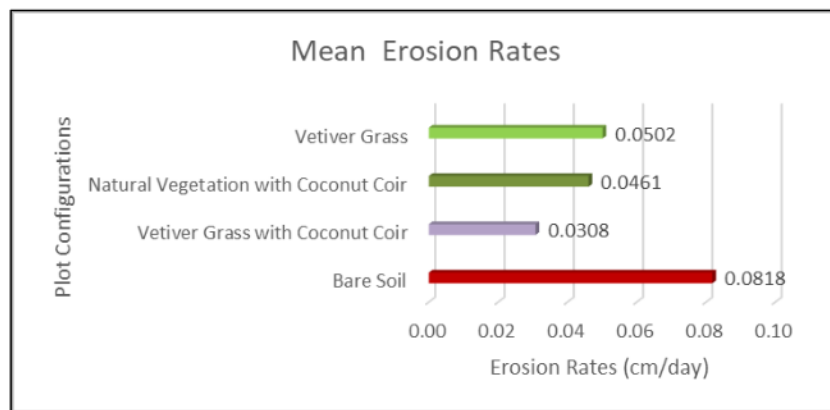
**Figure 7:** Tabulation of erosion rates mean value

The mean value of the erosion rates for every plot is calculated to exhibit the riverbank erosion that has occurred. The mean value for erosion rates of each plot is calculated by averaging the exposed length for each pin divided by the number of data collection days. The mean value of erosion rates for every plot is shown in Figure 7. The highest mean of erosion rates was exhibited by the bare soil plot, which is 0.0818 cm/day, and the lowest is in vetiver grass with coconut coir plot which is 0.0360 cm/day. Therefore, it is proven that vetiver grass with coconut coir is the most effective in protecting the riverbank from erosion, followed by the natural vegetation with coconut coir (0.0461 cm/day) and vetiver grass installed independently (0.0502 cm/day).

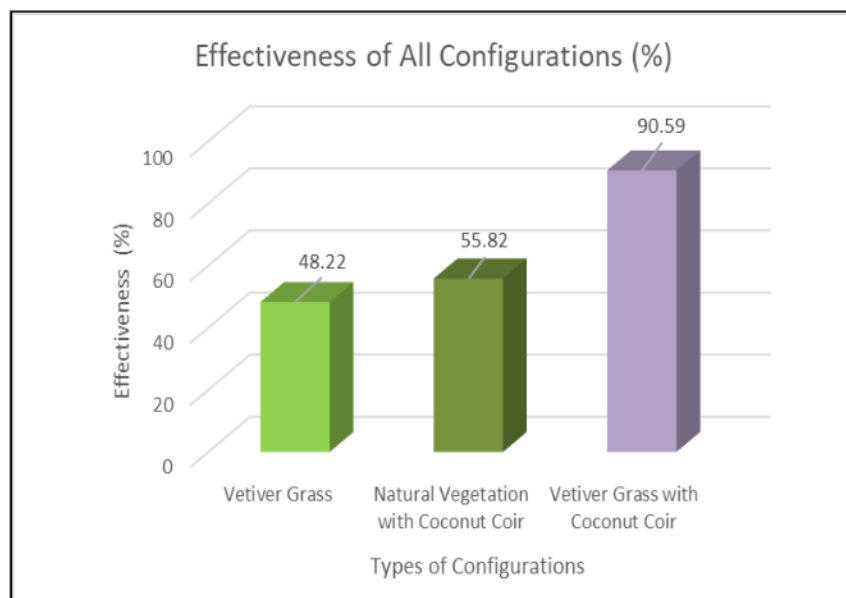
**Figure 8:** Effectiveness of all condition types to reduce erosion rates

The output of the mean values for erosions of each plot could also be represented in terms of effectiveness expressed as percentage difference of the mean erosion rates of the various configurations against that of bare soil.

Results show the highest percentage of effectiveness was obtained for the configuration of vetiver grass with coconut coir at 90.59% as compared to its counterparts shown in Figure 8. Ultimately, this indicates the application of vetiver grass with coconut coir matting is proven to be the most effective solution to treat the riverbank erosion at the Pusu River.

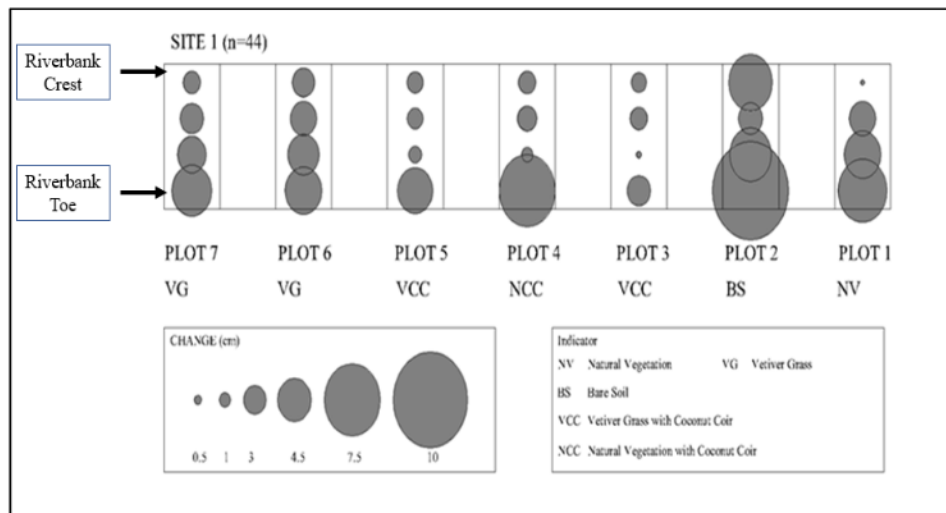
Figure 9: Spatial variation of all configuration

In order to provide a different perspective of the erosion that occurred at the riverbank, spatial variation of erosion values at each pin was introduced. This erosion value denotes the change of the exposed length of the pin from the beginning to the end of the observation period. In Figure 9, the magnitude of this change is represented by the size of the circle.

The bare soil plot demonstrated the biggest change of erosion value compared to other types of configurations, which exceeds 10 cm at the toe of the plot. Conversely, the lowest change of erosion value was exhibited by the vetiver grass with the coconut coir configuration followed by natural vegetation with coconut coir, vetiver grass only and lastly the natural grass on its own.

Figure 9 also demonstrated that the erosion majorly happened at the toe of each plot. However, the proposed method, which is the application of the

vetiver grass with coconut coir, still provides good protection as it lessens the change in measurement at the toe of the riverbank.
