Accessible Built Environment for the Elderly and Disabled in Malaysia: Hotels as Case Studies

*Asiah Abdul Rahim¹ and Nur Amirah Abd. Samad²

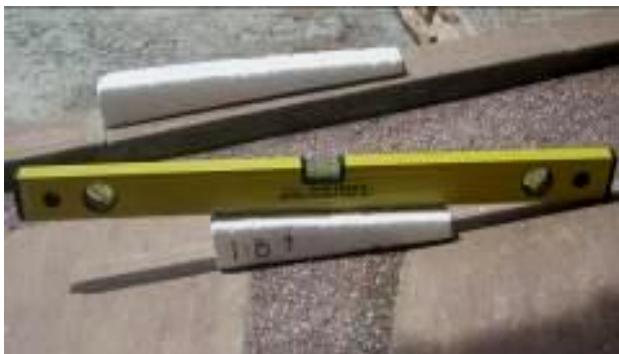
Figure 1. Using gradient model and levelling to measure the slope of the ramps
Source: Research.

To ensure that each ramp exhibited a slope in accordance with the standards, levelling was performed along with gradient modelling to determine the slope level of the ramp. The gradient modelling that was used during the access audit was provided in four ratios, 1:8, 1:10, 1:12 and 1:14. Ramps that are constructed with slopes of 1:10, 1:8 or steeper are not safe for wheelchair users.

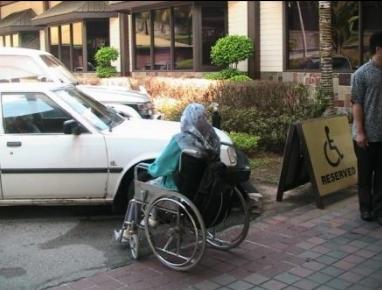
Figure 2. Accessible parking provided for the disabled with mobile signage.

ELEMENT	DESCRIPTION OF EXISTING FEATURES	PROPOSAL / RECOMMENDATION
PARKING	<p>Wheelchair User</p> <ul style="list-style-type: none"> - Mobile signage for parking. - It is visible, but because it can be moved, the parking might be taken by other people. 	<ul style="list-style-type: none"> - Fixed standing signage to indicate accessible parking is recommended.

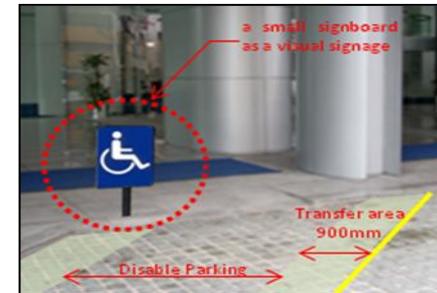
Figure 3. Example of small signboard to indicate accessibility for disabled parking.

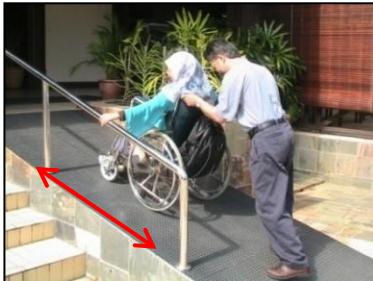
<p>Wheelchair User</p> <ul style="list-style-type: none">- Swimming pool area is difficult to be reach due to a steep ramp with a 1:7 gradient ratio. The wheelchair users require assistance to reach the swimming pool areas. <p>Vision Impaired</p> <ul style="list-style-type: none">- Tactile warning surface is not provided at the edge of the steps.	<ul style="list-style-type: none">- Existing steep ramp should be adjusted to 1:12 gradient with railing on both sides and provided with a 100 mm kerb at the edging.- To provide a tactile warning surface at the edge of the steps and at the beginning of the ramp for visually impaired people.

Figure 4: The steep ramp is not easy to use for wheelchair users.

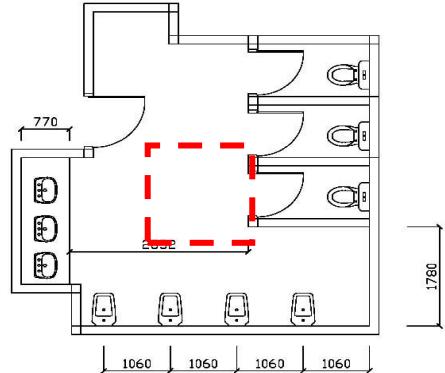
ELEMENT	DESCRIPTION OF EXISTING FEATURES	PROPOSAL / RECOMMENDATION
PUBLIC TOILET	<p>Wheelchair users</p> <ul style="list-style-type: none"> - Located at the lobby area. No signage for the disabled. <p>a) Male toilet</p> <ul style="list-style-type: none"> - Male toilet is accessible. Space is large enough to manoeuvre. The size is acceptable. There is railing installed and accessible to the urinal. An appropriate washbasin height with a 600 mm door clearance is provided. 	<ul style="list-style-type: none"> - One unit for PWDs in the male toilet and female toilet, each near the restaurant, is proposed. - Install tactile warning surfaces at the entrance of the wheelchair and attach signage for the disabled.

Figure 7. Signage for the disabled toilet is not included.

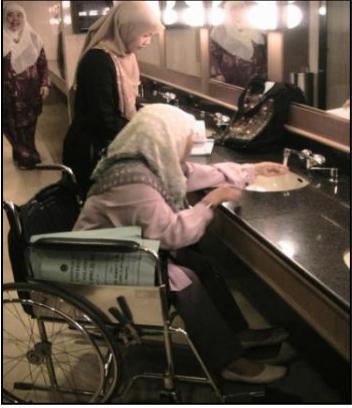
<p>b) Female toilet</p> <ul style="list-style-type: none"> - The female toilet is accessible, but railing is not provided inside of the toilet area. The sink counter is acceptable and is accessible to the water tap. The hair dryer is accessible except that the tissue paper discharger to wipe the hands is not accessible. <p>Vision Impaired</p> <ul style="list-style-type: none"> - The label for gender is not embossed. This creates difficulties for visually impaired people to identify the toilet.

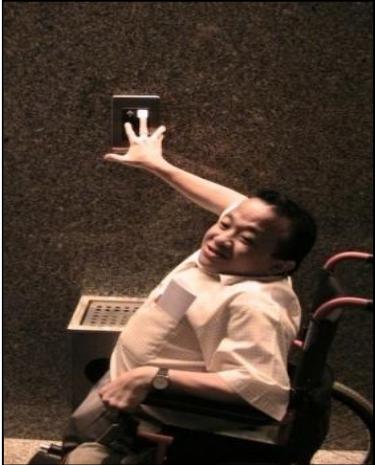
ELEMENT	DESCRIPTION OF EXISTING FEATURES	PROPOSAL / RECOMMENDATION
ELEVATORS / LIFTS	<p>Wheelchair User</p> <ul style="list-style-type: none"> - The buttons are accessible by wheelchair users. The call button is 1200 mm from the floor level. - Handrails mounted on three sides of the lift at a height of 800 mm from the floor level with a 40-mm diameter. <p>Vision Impaired</p> <ul style="list-style-type: none"> - Four talking lifts are provided. - Braille for the blind is not provided but it is embossed. - No tactile warning surface installed in front of the lifts. - Control panel is not installed with Braille (Height = 800 mm) 	<ul style="list-style-type: none"> - A tactile warning surface and Braille should be provided in front of the lift and Braille for visually impaired people.

Figure 11. Call button is within reach for wheelchair users.

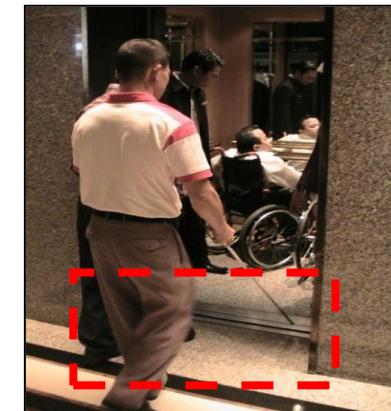
Figure 12. Proposed location for the installation of tactile warning surfaces.

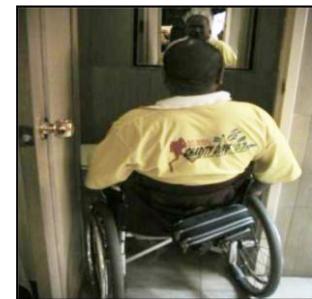
ELEMENT	DESCRIPTION OF EXISTING FEATURES	PROPOSAL / RECOMMENDATION
HOTEL ROOM	<p>Wheelchair Users</p> <ul style="list-style-type: none"> - The room is accessible. Unfortunately, the door width at the toilet is too narrow for wheelchair users. There is a threshold of 1 inch before entering the toilet. Circulation area is acceptable. However, it is difficult to obtain access for wheelchairs and is impossible to enter the shower. The bath tub is also inaccessible. - Toilet door is too narrow (750 mm) 	<ul style="list-style-type: none"> - Increase the door width at the toilet from 760 mm to 1000 mm. - Remove the threshold at the main entrance door for wheelchairs. - Remove the glass door, provide a curtain and remove the threshold at the shower area. - Shower door opening should be 1000 mm wide.
Room 521 (Standard Double Bed)	<p>Wheelchair Users</p> <ul style="list-style-type: none"> - The room is accessible, but the toilets are inaccessible by the wheelchair users. - 1-inch threshold obstructs wheelchair users upon entering the toilet. 	<ul style="list-style-type: none"> - The standard room is not recommended for the wheelchair users. - To create drop that is lay to fall at threshold area.

Figure 14. The occurrence of 1-inch threshold towards the shower areas.
