PAINTING PROCESS IMPROVEMENT THROUGH SIX SIGMA APPROACH IN A MALAYSIAN VEHICLE ASSEMBLY COMPANY

Keywords: Six Sigma, DMAIC, automotive assembly, painting process

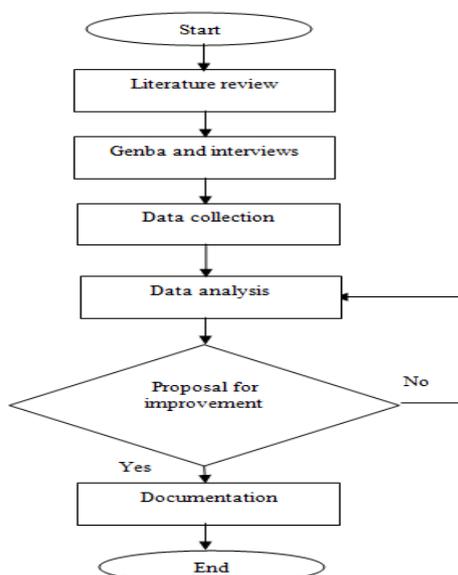
Figure 1: Flowchart of methodology

Experimental Procedure. The research focused on only one automotive company using case study method. Existing painting process was defined and mapped to understand the process characteristics and capabilities. It was then analyzed to identify problem areas, variations and possible solutions were suggested with process coordination and control measures. Data collected in this study include observations, interviews and literature studies (Yin, 2003). Both primary and secondary data have been used during these improvement activities. Examples of primary data are factorial experiments conducted throughout the project. Internal reports and data automatically collected by a production monitoring system are examples of secondary data. To deal with the internal validity, statistical analysis of the data has been used. All personnel involved in the investigated process were interviewed continuously during the project and the outcomes of these interviews were documented right after the interviews. Most of the interviews were conducted unstructured with low level of standardization. Figure 1 show the methodology used in this study.

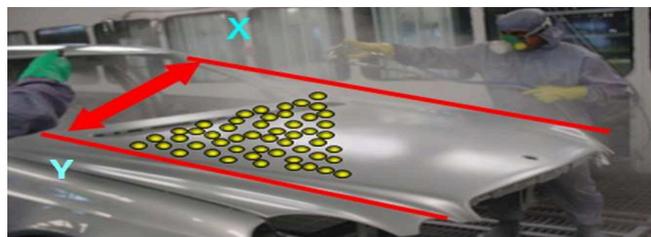
Figure 2: Fiber defect detection through Genba checks

Genba checks were carried out in the Top Coat spray booth during spraying process and it was found out that fiber defects were created in X - Y area (Figure 2).

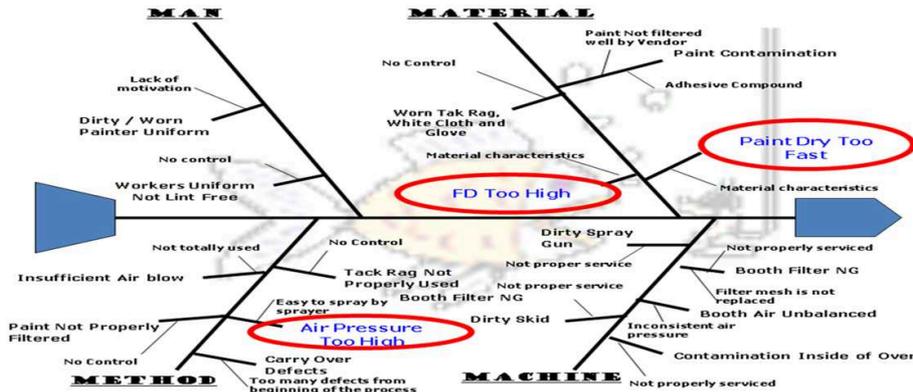
Figure 3: Cause and Effect Diagram for fiber defect

Analysis on the possible causes of fibers was carried out using the cause-and-effect diagram (Figure 3). Fibers could have been caused by dirty painter uniforms but the workers working in the Paint Shop were already given lint-free uniform. Changing the uniform periodically for one trial period also did not reduce the fiber count. Potential causes of fibers were associated with contamination in the material used in the painting process. Action taken to filter the paint up to three times the usual filtration rate also did not resolve the fiber defects. The tack rags which might create fibers were changed and their use controlled but to no avail. Dirty spray guns and skids were periodically cleaned but the problems persisted. For methods, possible causes include contaminated oven, imbalanced air pressure in the spray booth, insufficient air blow and defects carried over from previous painting. Measures taken including increasing frequency of oven cleaning, carrying out total booth refurbishment and re-balancing of spray booth, ensuring sufficient air blow and finally carrying out 100 percent inspection after primer sanding process failed to reduce the number of fibers detected.

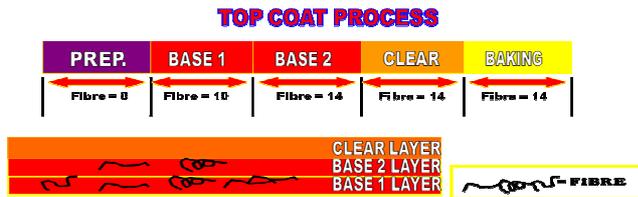
Figure 4: Accumulation of fibers during spraying process

Figure 4 illustrates fiber accumulation in top coat can from preparation station to baking process detected during inspection. After many trials, it was found that during the spraying process, paint overspraying, paint spitting and paint drying too fast had caused the accumulation of fibers on the painted body with the fibers originating from the paint material itself. The first root cause was too much overspray due to air pressure setting recommended by the supplier was too high (5 to 5.5 bars). High air pressure setting was for easy spraying i.e. paint coverage was high and spraying time short. The second root cause was paint spitting caused by inappropriate (high) fluid delivery setting for polyester-based paint. The third root cause was due to paint drying too fast thus unable to absorb paint overspray which then turned into fibers.

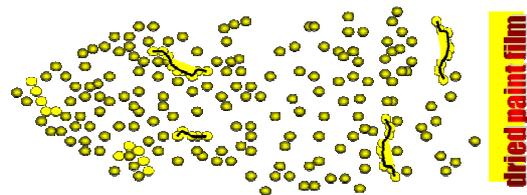
Figure 5: The forming of paint particle chain

High fluid delivery resulted in more paint particles triggered during spraying causing overspray and paint spitting (Figure 5). The paint particles will link to each other forming long chains of paint particles resulting in fibers. High air pressure induced the formation of more fibers through particles knocking each other. The long chain of paint particles turned into higher molecular weight fibers and dropped on the surface of semi-dried paint film and remained on the painted body and detected as fibers which can be clearly seen with naked eyes.

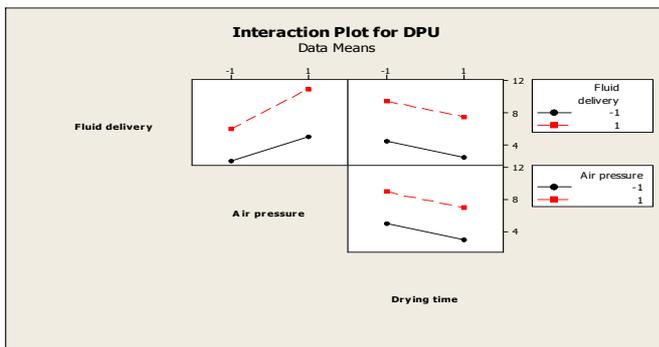
Figure 6: Interaction diagram for DPU

It can be concluded from the DOE that adjusting the parameter setting of the spraying gun had reduced the fiber count in the paint materials (Figure 6). The optimum combinations for the spray gun are (1) the fluid delivery was set at 450 ml/minutes, (2) the air pressure was set at 3.5 bar and (3) adjusting paint drying time from 0.5 second to 1.5 second by adding slow boiling thinner. As shown in Figure 7 the improvement activities was able to reduce fiber DPU from 10 to 1 DPU in September 2012 with DPU of foreign material also dropped from 100 to 50. The figures must be maintained through monitoring of the process by the personnels responsible. Before improvement, vehicles needed to be re-sprayed due to fibers present. Rework units needs to go through sanding process all

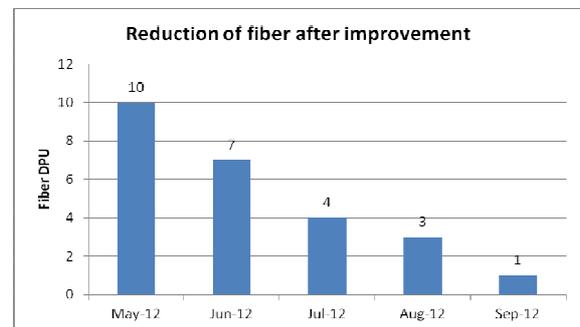
Figure 7: Reduction of fiber after improvement
