# An Experimental Investigation on Surface Quality of CFRP after Milling in Cutting Fluid Environment

Aisyah Madihah Mustafa<sup>1</sup>, Ahmad Basyir Ahd Suhaimi<sup>1</sup>, Najlah Sakinah Shahrudin<sup>1</sup> and Nor Farah Huda Abdul Halim<sup>1</sup>

<sup>1</sup>*Department of Manufacturing and Materials Engineering, Kulliyah of Engineering, International Islamic University Malaysia, 53100 Gombak*

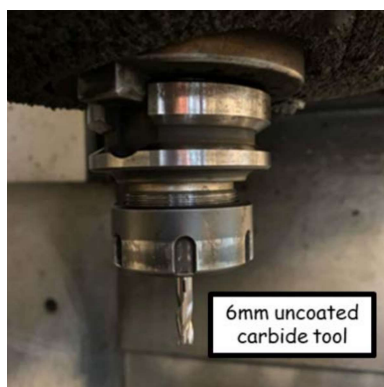
**Figure 1.** 6mm diameter uncoated tungsten carbide tool mounted on the machine spindle

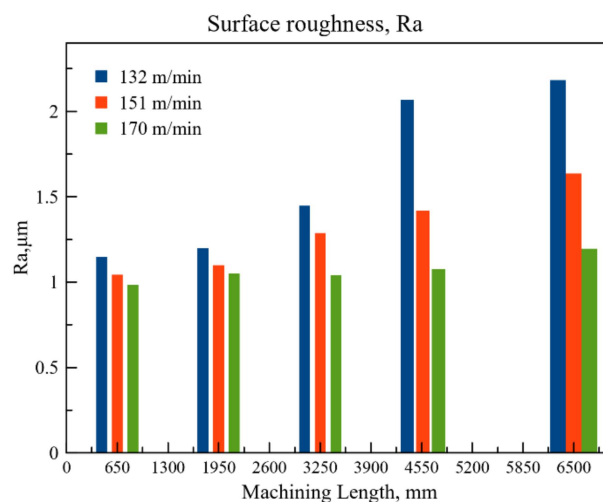
**Figure 3.** Average surface roughness, Ra of the CFRP machined surface measured by Alicona Infinite Focus SL

Figure 3 shows the progression of surface roughness of CFRP machined surface when milling with three cutting speeds after 6500 mm machining length with the presence of cutting fluid. It can be seen the surface roughness increases with the increasing of machining length for all cutting speed. This is caused by the rounded of cutting-edge radius attributed from the increasing of tool wear along the machining length. Besides, due to the anisotropic and heterogeneous structures of CFRP that produced brittle fracture instead of plastic deformation at the working zone, excessive tool wear can occur with increasing of the cutting distance which was also supported by Halim et. al [6].

However, opposite phenomenon can be observed in studying the relationship between the surface roughness and the cutting speed as the surface roughness decreases with increasing of the cutting speed. High cutting speed of 170 m/min shows a better surface roughness of 1.193  $\mu\text{m}$  with minimal increment compared to other cutting speeds. The highest average surface roughness was observed to be at 2.181  $\mu\text{m}$  after milled with cutting speed of 132 m/min at cutting distance of 6500 mm, 45.3% higher compared to 170 m/min. This is due to the higher cutting temperature generated during machining in high cutting speed softens the matrix resin, offering less friction between the cutting tool and the machined surface thus eases the CFRP removal process. It is suggested that the softening of the matrix resin was occurred during milling of CFRP [4,7]. Figure 4 shows the topography image and its surface roughness profile of CFRP strips after 650 mm and 6500 mm of machining length for cutting speed of 132 m/min analysed under Alicona SL 3D. A lot of purple spots were observed at cutting distance of 6500 mm which indicates significant areas with fiber pull-out compared to cutting distance of 650 mm. At highest cutting
