# Anterior teeth rehabilitation with direct resin composite veneer using multiple layering technique: A case report

Department of Restorative Dentistry, Kulliyah of Dentistry, IIUM Kuantan Campus

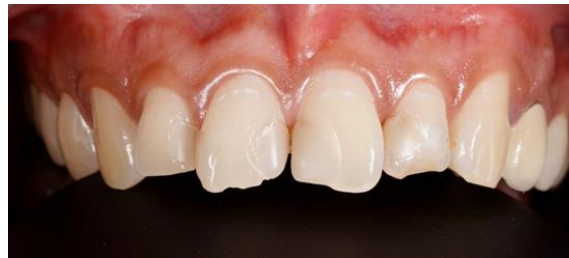
Upon clinical examinations, the existing restoration appears to be discoloured and there is secondary caries detected at the mesial of left maxillary central incisor and over-hanging restoration on the mesial of the right maxillary central incisor. The incisal edge of both maxillary central incisors was also slanted unfavourably to the patient's aesthetic needs (Figure 1). Pulp sensibility and periodontal probing were also done to assess the pulp and periodontal status of the tooth in which all the tooth that need to be restored responded normally to the test and free of periodontal problem. Occlusion between both upper and lower dentition were also assessed to ensure harmonious inter-arch occlusion relationship (Figure 2). The remaining tooth structures were adequate for both teeth to receive dental veneers but due to the limited budget and time constraint, the patient agrees to the DCV method for both teeth instead of indirect veneer technique. The tooth will be restored directly using resin composite by removing previous restorations with minimal preparations for the veneer. Incorporation of proper incisal edges also will be done along with an attempt to recreate natural anatomical features as close as possible.

Figure 1. Pre-operative view. Slanted incisal angles of tooth 11 and 21, a visible shadow also noted at mesial of 21 indicated secondary caries under the existing restoration.

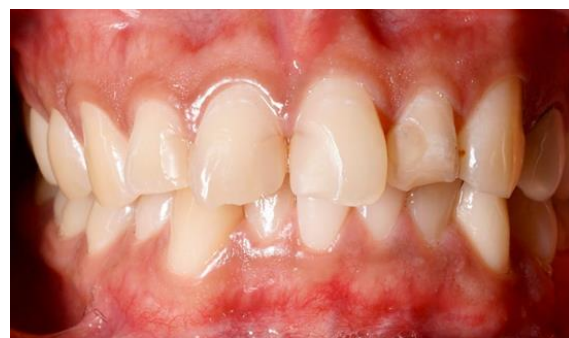
Figure 2. Pre-operative view. Inter-arch relationship of both upper and lower anterior dentition.

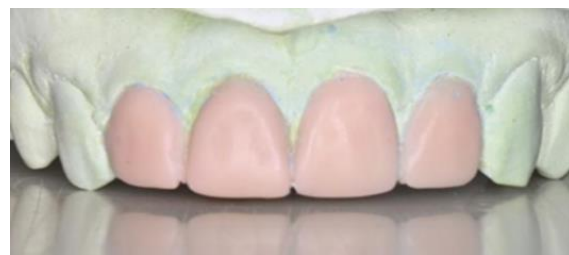
Figure 3. Diagnostic cast with wax up on tooth 13 until 23. Putty matrix was prepared based on this diagnostic wax-up including from tooth 13 until 23.

A diagnostic wax-up was made on the study cast to give an overview of the expected outcomes of the restorations to the patient (Figure 3). Silicone index was also made from the wax-up which include from upper right canine to the left contralateral side to serve as guide in placement of palatal shell. The tooth shade was determined before the commencement of treatment using VITA classical A1-D4® shade guide (VITA Zahnfabrik, Bad Säckingen, Germany) and

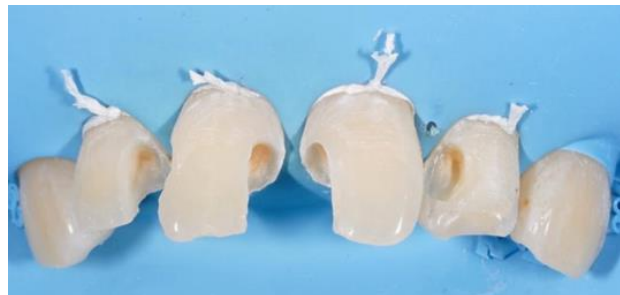
Figure 4. Rubber dam placement and removal of previous restoration and carious tissue. Notice the affected dentine was left unprepared and will be covered with liner.

Following maxillary infiltration on the respective tooth was done, a rubber dam is placed using multiple isolations from right maxillary canine to the left maxillary canine. Removal of previous restoration and carious tissue was done until caries-free is achieved on all of the teeth with round shaped diamond bur. Affected dentine present at the prepared tooth is left unprepared and covered with glass ionomer cement as a liner (Figure 4). Minimal preparation was made on the labial surface to include beveling and conservative labial reduction of 0.3 mm using diamond chamfer bur. The selective etching was done on the enamel surfaces with 37% phosphoric acid (Eco-Etch® gel,

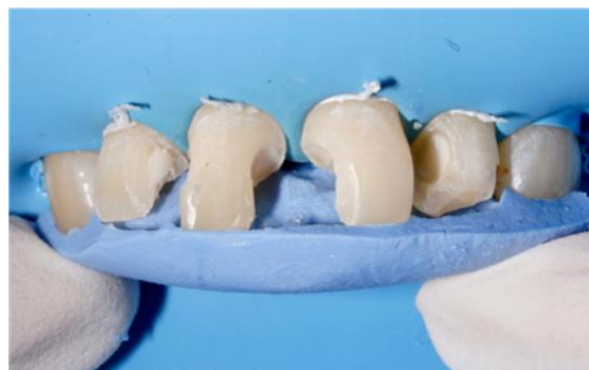
Figure 5. Silicone index fabricated prior to the treatment was used as guide to build up palatal shell and proximal border.

For resin composite placement (ceram.x duo®, Dentsply Sirona, Konstanz, Germany), palatal shell and the proximal wall was first established with enamel shade of E2 guided using silicone index constructed beforehand (Figure 5 & Figure 6). Subsequently, resin composite (ceram.x duo®, Dentsply Sirona, Konstanz, Germany) with shade D2 is used for dentine layering which was done incrementally and light-cured for 20 seconds

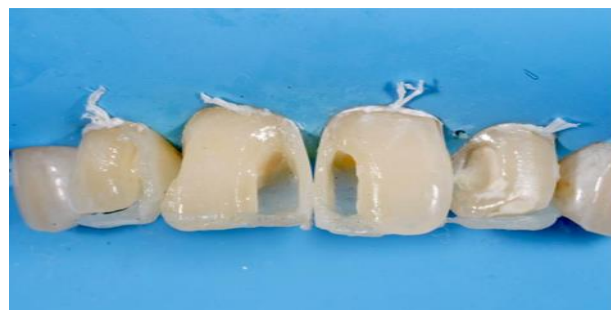
Figure 6. Both palatal shell and proximal wall were built up using ceram.x® duo shade E2, to represent the enamel layer.

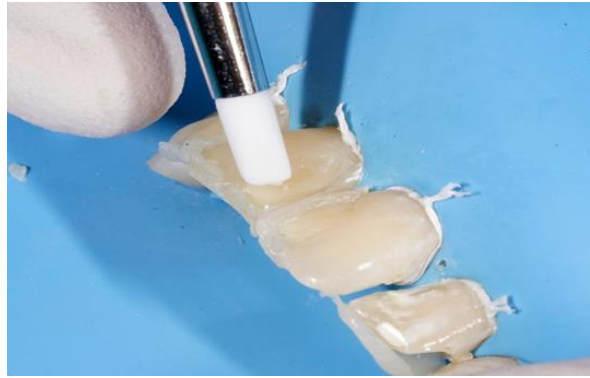
Figure 7. Application and layering of dentinal layer using ceram.x® duo shade D2. The procedure was aided by using silicone sculpture brush to ensure proper adaptation and smooth transition for each layering.

on each layer (Figure 7). The final layer of the labial surface is restored with resin composite enamel shade of E2 and light cured for 20 seconds before removal of the rubber dam. Each layering and contouring done using flat end plastic instrument along with silicone sculptor to ensure proper adaptation and smooth transition between restoration and tooth structure.

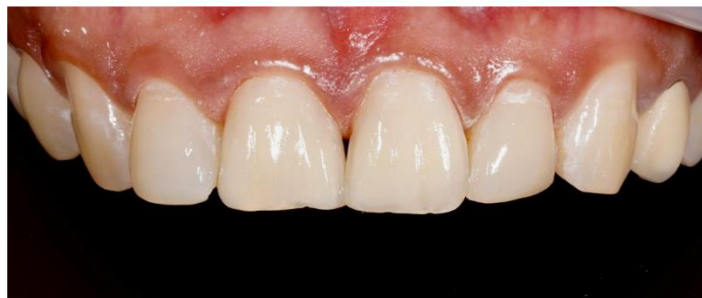
Figure 8. Post-operative appearance of the restoration

Finishing of the restoration was done using fine needle diamond bur and abrasive disk (Super Snap, Shofu Inc, Kyoto, Japan) to

contour the surface anatomy. Final finishing is then completed using Enhance® (Dentsply Sirona, Konstanz, Germany) system with polishing paste (Prisma-Gloss®, Dentsply Sirona, Konstanz, Germany). The restoration then polished with PoGo™ polishers (Dentsply Sirona, Konstanz, Germany). Each tooth is restored using the same protocol simulating to the adjacent tooth (Figure 8). After one week, the patient was recalled for review and there was no post-operative sensitivity and aesthetic or functional problem (Figure 9).

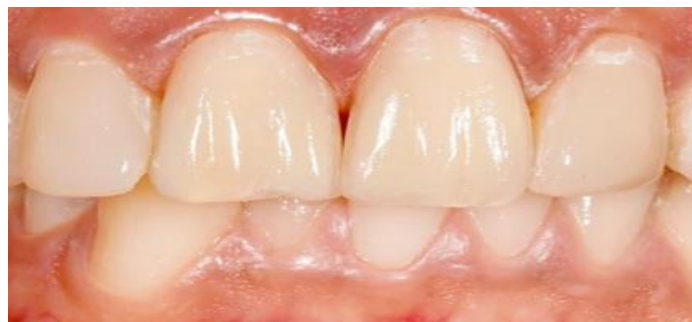
Figure 9. The restoration at one-week recall shows the optimal blending between restoration and tooth structure.
